# Manhole Inspection Summary

Manhole # S25C\_\_036MH

Insp Date: **8/3/07 8:12 AM**

**Location** Address: **1037 MULBERRY ST**

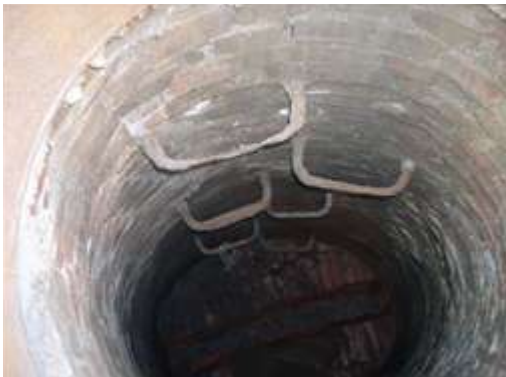
Defect 3

**Steps** Count: **6** Missing: **0** ☒ **Corroded**

CORRODED STEPS

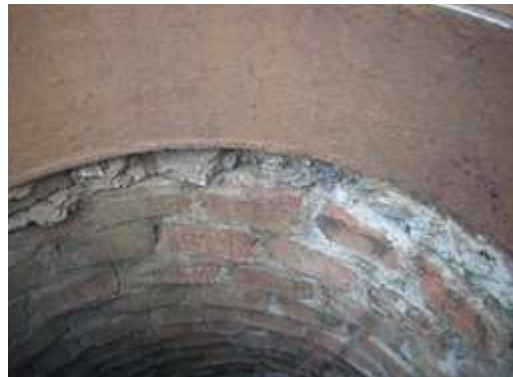
Defect 2

Condition: ☐ Sound ☐ Cracked ☐ Root Intrusion ☐ Loose Brick ☒ **Deteriorated**

DETERIORATED CORBEL

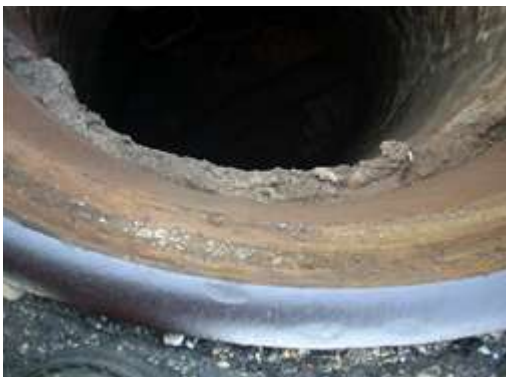
Defect 1

**Frame** Offset: **1** (in.) Condition: ☒ Sound ☐ Cracked ☐ Leaks

FRAME OFFSET

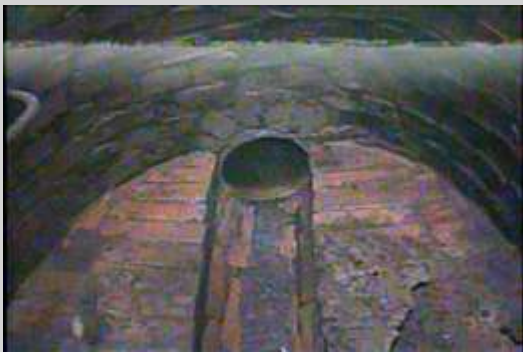
12 O'Clock Outflow

8 in. Circular Gravity Sewer  
Pipe Out @ 12 O'Clock

Pipe Height: **8.4** (in.) Rod and Bar (Angled)  
Pipe Material: **Clay** ☐ Pipe Lined  
Invert Depth: **9.98** (ft.) Flow Characteristics: **None**  
Deposits: ☒ None ☐ Mud ☐ Sludge ☐ Debris ☐ Grease  
Silt Depth: (in.) Deposits Extent:  
Infiltration: **None** Pipe Seal Cond: **Sound**

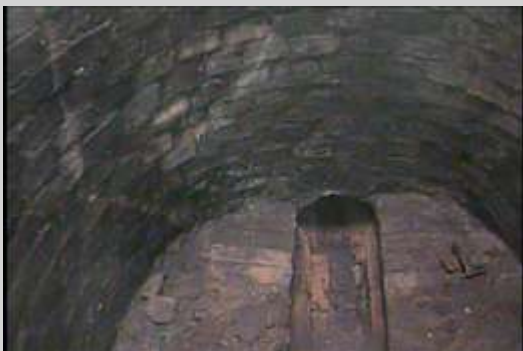
6 O'Clock Inflow

8 in. Circular Gravity Sewer  
Pipe In @ 6 O'Clock

Pipe Height: **7.2** (in.) Rod and Bar (Angled)  
Pipe Material: **Clay** ☐ Pipe Lined  
Invert Depth: **9.80** (ft.) Flow Characteristics: **None**  
Deposits: ☒ None ☐ Mud ☐ Sludge ☐ Debris ☐ Grease  
Silt Depth: (in.) Deposits Extent:  
Infiltration: **None** Pipe Seal Cond: **Sound**
